HOME INSPECTION REPORT

5896 HAPPYVIEW CT, RANCHO SANTA FE, CA 92067

Date: 3/9/2017Time: 08:00 AMReport ID: 3-9-17-HAPPYCLIENTProperty:Customer:Real Estate Professional:

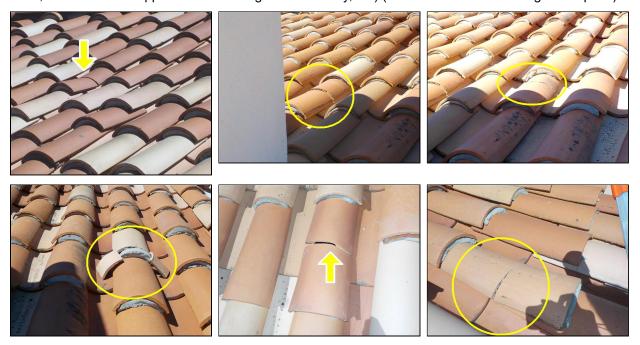
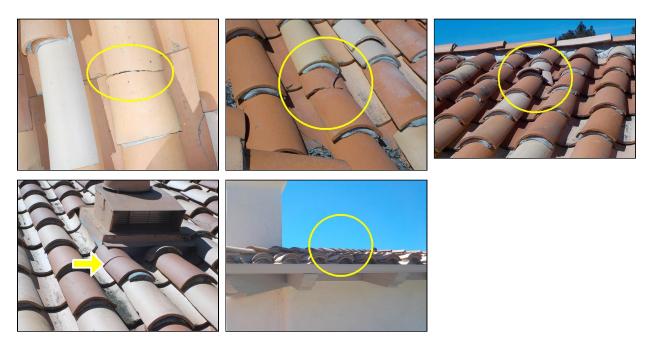
PRIORITY
REPAIR
(2) There are a number of broken roof tiles which should be serviced or the roof may leak.
Evaluation and repair of the entire roof by a licensed Roofing Contractor is recommended. (above the family room, kitchen and on upper roof near living room chimney, etc) (seller has invoice showing roof repairs)

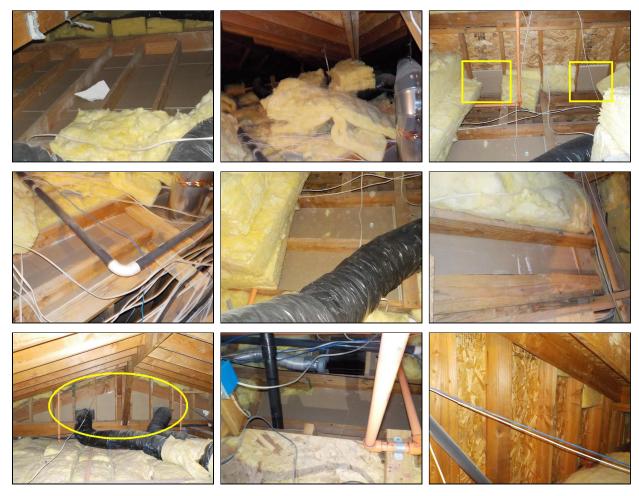
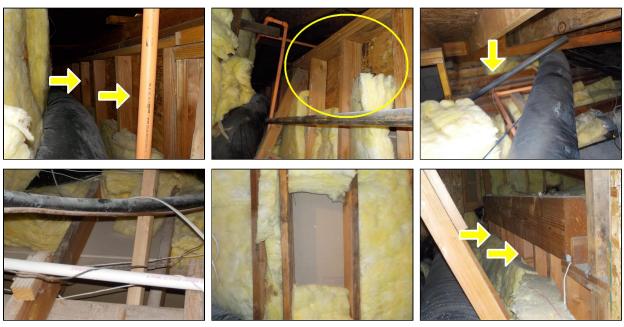
REPLACE (1) There are several bare areas where insulation is displaced or missing and it should be re installed or replaced to avoid temperature transfer from the attic to the living space. Evaluation and repair by a licensed Contractor is recommended.

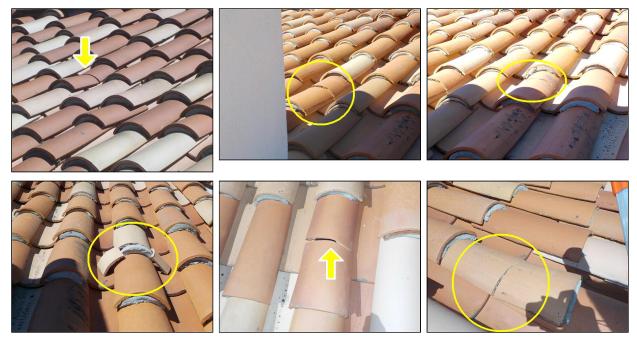
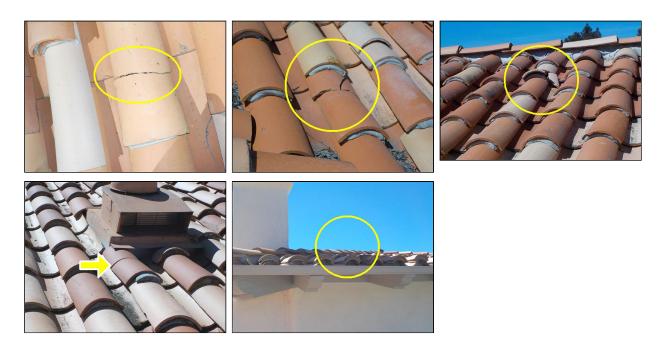
(2) There are a number of broken roof tiles which should be serviced or the roof may leak. Evaluation and repair of the entire roof by a licensed Roofing Contractor is recommended. (above the family room, kitchen and on upper roof near living room chimney, etc.) (seller has invoice showing roof repairs)

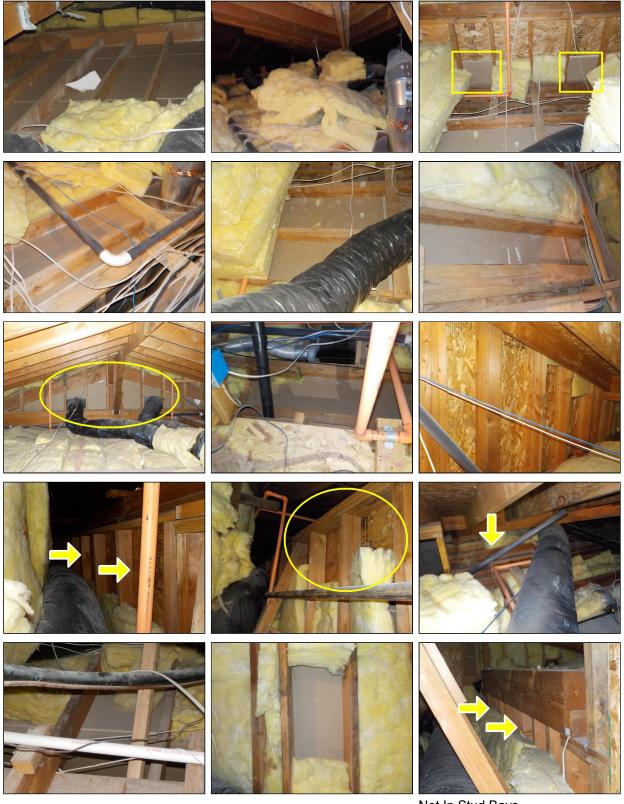
(1) There are several bare areas where insulation is displaced or missing and it should be re installed or replaced to avoid temperature transfer from the attic to the living space. Evaluation and repair by a licensed Contractor is recommended.
