## HOME INSPECTION REPORT

**JOE BUYER**

1234 ALLRIGHT AVE, CARLSBAD, CA 92009

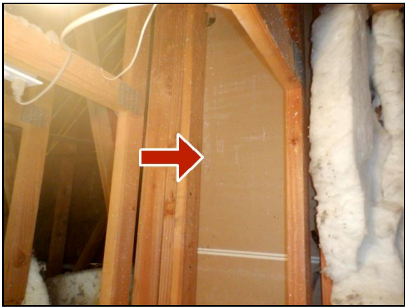
(1) There are one or more bare areas where insulation is displaced and it should be reinstalled to prevent temperature transfer from the attic to the living space.

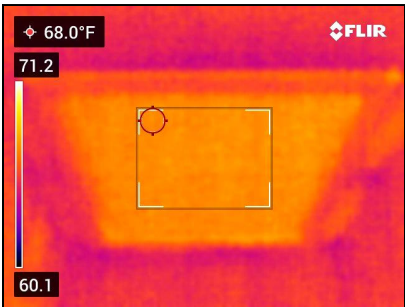
(2) The attic access covers are not insulated and should be serviced for energy efficiency.

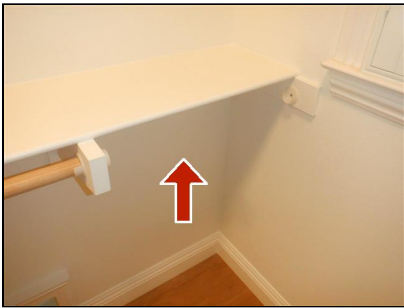
A closet rod in the primary bedroom is missing and should be replaced.

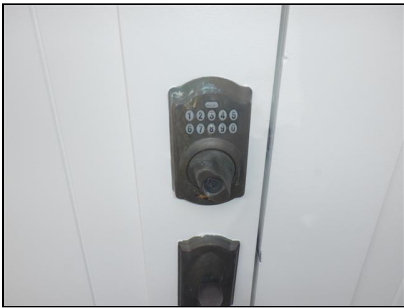
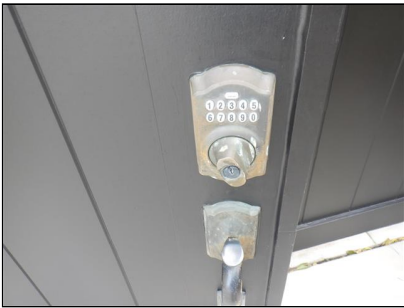
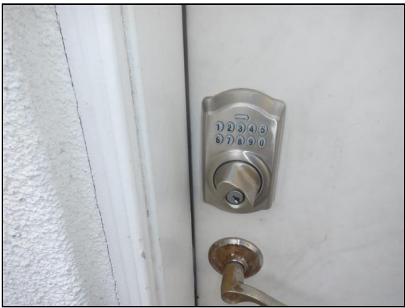
There are door and gate locksets with combination locks, that should be demonstrated to be functional.(Not all pictured here)

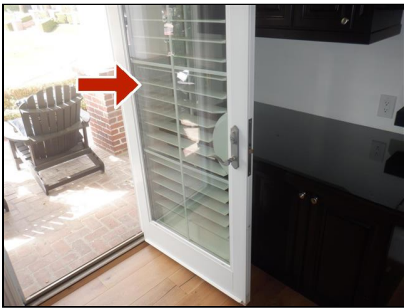
(1) There is a French door in the office with delaminated low-e tint, which is due to a manufacturer's defect. Inquire with the seller about any documentation regarding the door manufacturer and any warranty that may apply. Service by a qualified Window Contractor is recommended.

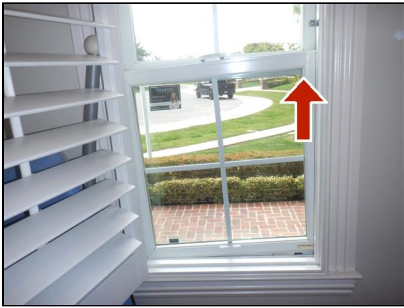
(2) Six or more windows have damaged balancers and should be serviced for the windows to open and close properly or to stay open.

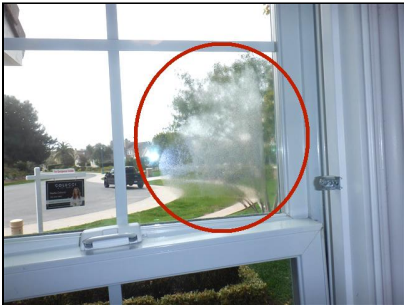
**REPAIR / REPLACE** (4) There are 11 or more windows with broken hermetic seals, (fogged windows), which should be replaced. Condensation or fogging may continue to form between the panes of glass over time making them more unsightly.

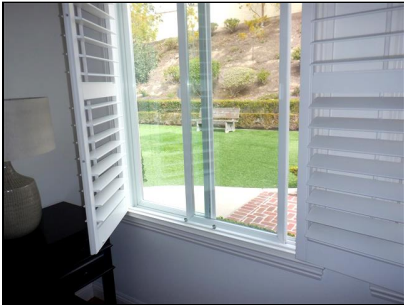
**REPAIR / REPLACE** (5) A window in the primary bedroom drags the track and the rollers should be serviced.

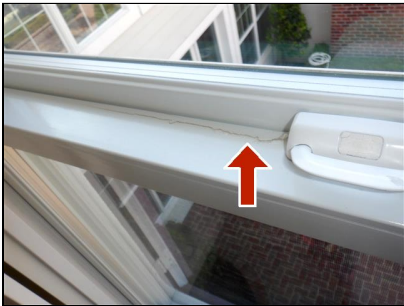
**REPAIR / REPLACE** (6) A window in bedroom 4 has a cracked/damaged sash and should be serviced.

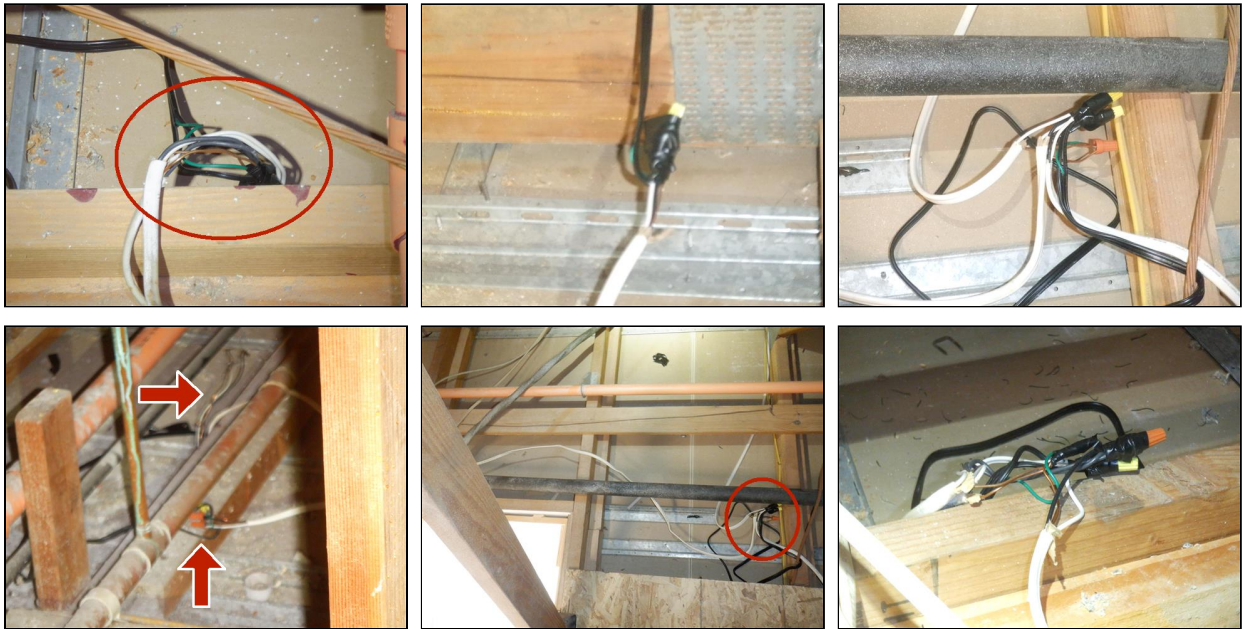
(1) Electrical connections in the garage attic have been made outside of junction boxes which pose a potential fire hazard. All such connections should be inside of a junction box to contain a potential spark within the box. A qualified Electrician is recommended.

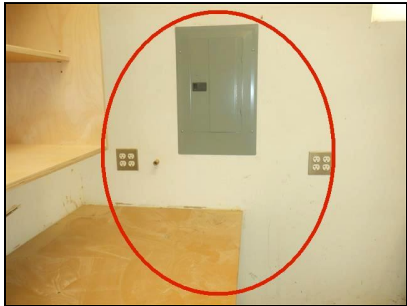
**REPAIR / REPLACE** (1) The sub panel in the workshop does not have 36 x 30 in. of clear space in front of it, which should be serviced.

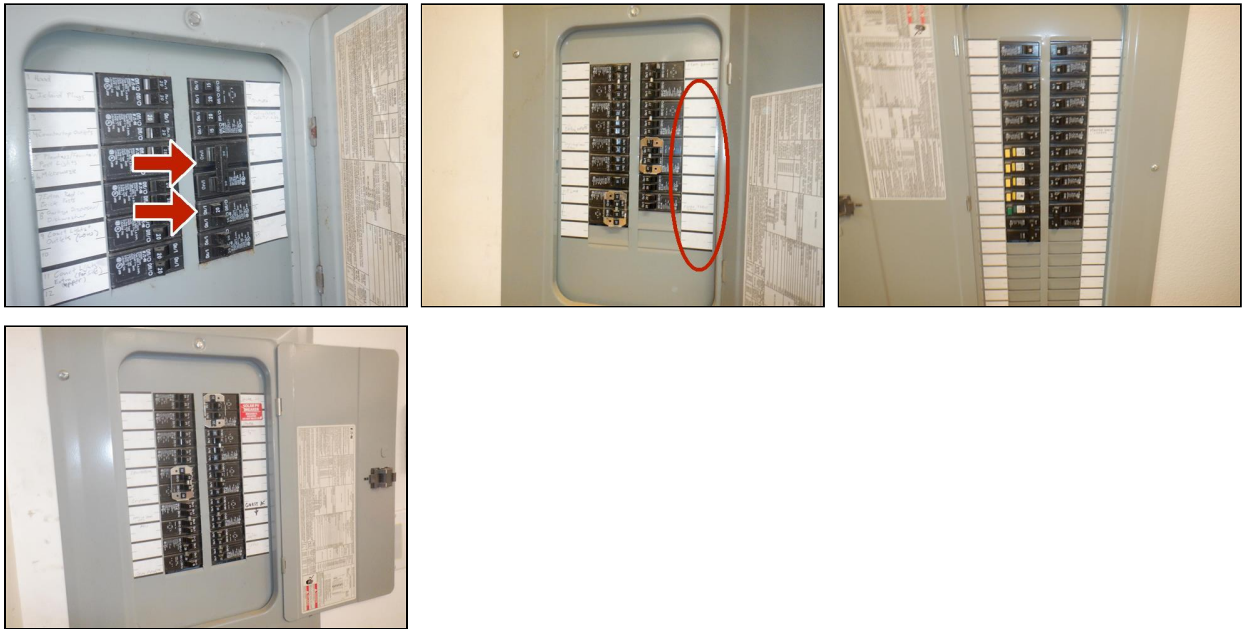
**REPAIR / REPLACE** (2) A number of circuits within the sub-panels are not labeled but should be, so that the appropriate load calculations and breaker sizes could be determined.

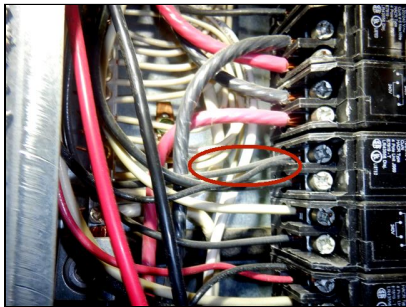
**SAFETY CONCERN** (1) A 20 amp circuit breaker in the garage workshop panel is serving two circuits, which could overload the circuit. The breaker is not designed for two conductors. Each conductor will not have enough contact area against the screw or its lug, which may lead to arcing and overheating of the conductors.

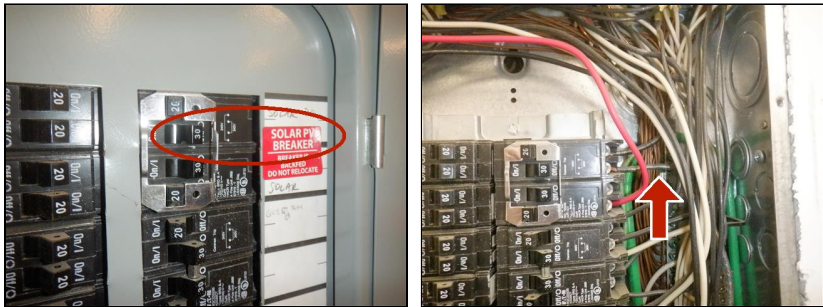
**SAFETY CONCERN** (2) There is a 30 amp 120 volt circuit within the exterior sub panel. 30 amps is for 240 volt circuits. The breaker is labeled Solar PV System. A qualified Electrician is recommended.

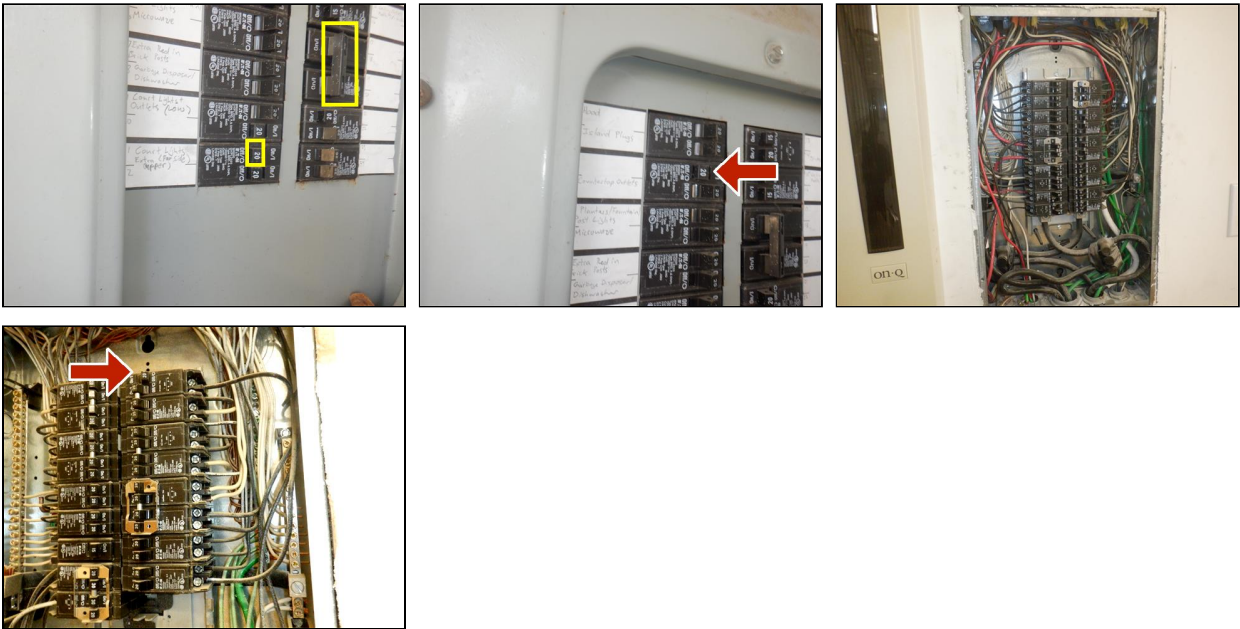
**REPAIR / REPLACE** (3) There are breakers in the exterior and garage workshop sub panels that were off at the time of the inspection. The circuits should be restored and confirmed to be powered.

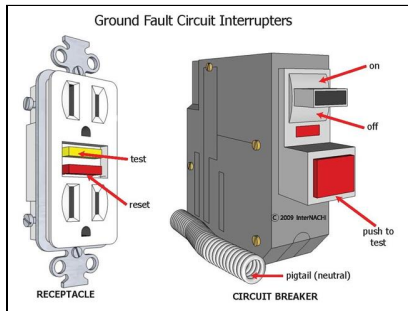
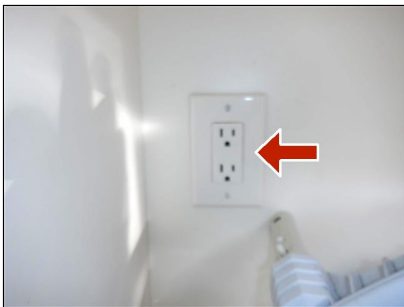
(1) A receptacle outlet in the exterior kitchen cabinet is not GFCI protected, which poses a safety hazard and should be serviced.

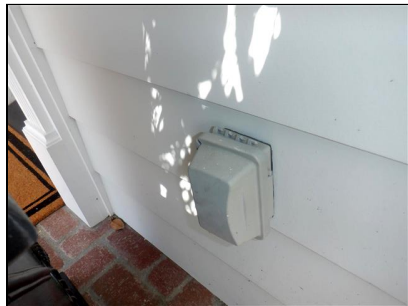
(2) A GFCI outlet at the porch tripped when tested and cannot not be reset. It should be serviced and confirmed to restore power to the front, left side and stairway landing outlets. There is a sprinkler timer on the circuit which needs power. A qualified Electrician is recommended

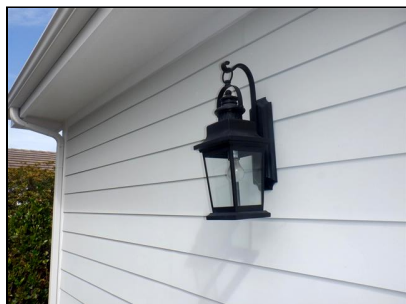
(2) The light at the guest house and workshop exterior did not respond and should be serviced and demonstrated to be functional.

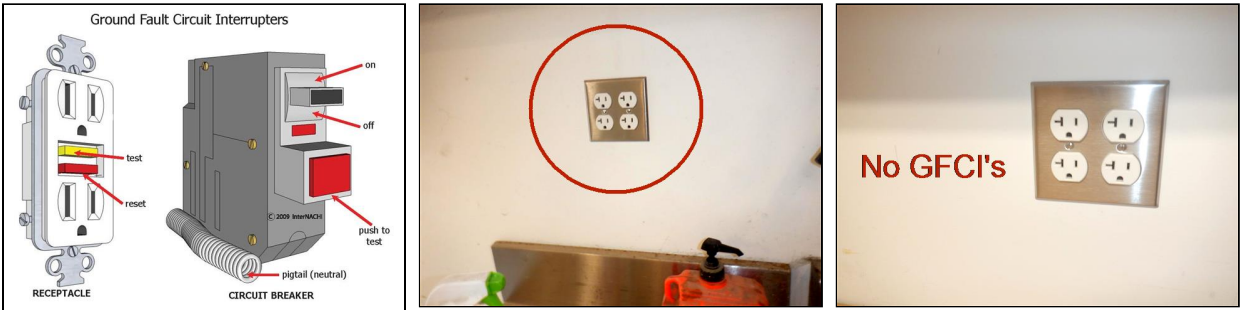
(1) The workshop and added garage receptacle outlets are not GFCI protected, which pose potential safety hazards and should be serviced.

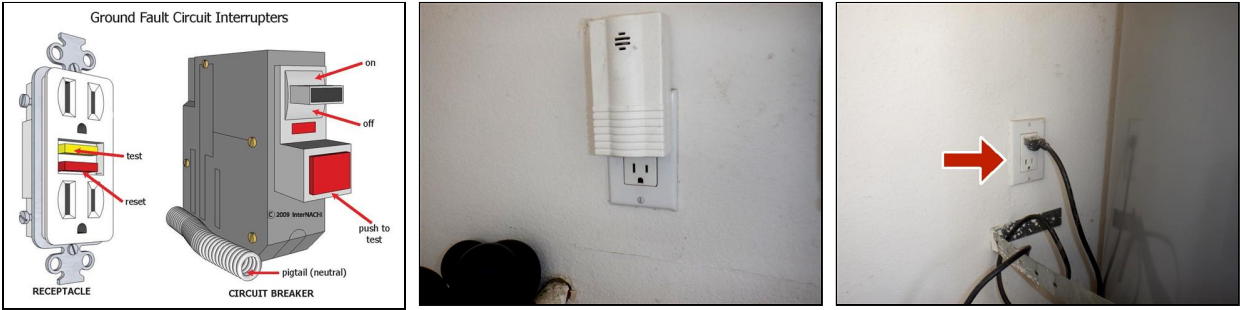
**SAFETY CONCERN** (2) Two attached garage receptacle outlets are not GFCI protected, which pose potential safety hazards and should be serviced.

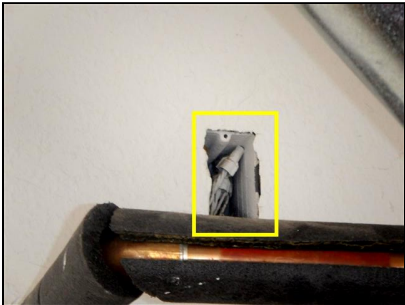
**SAFETY CONCERN** (1) There is an open electrical junction box by the water heater, which should be sealed so that any arching or sparking could be contained within the box.

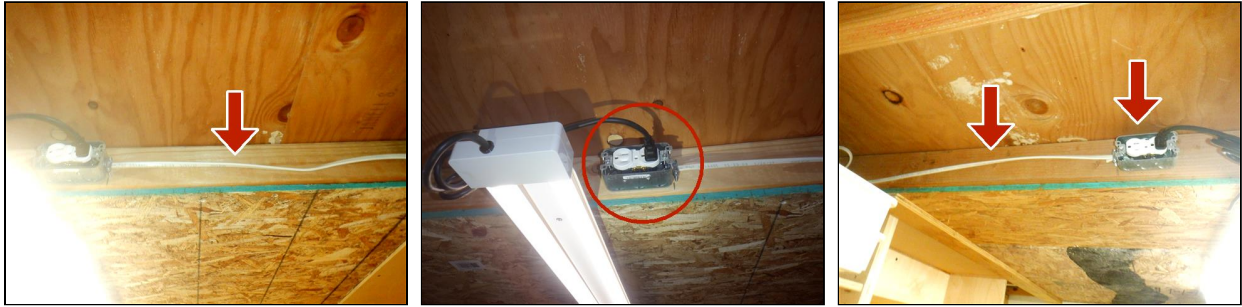
**REPAIR / REPLACE** (2) There is NM electrical cable within the workshop storage area, which is not properly secured and supported. It should be secured to the framing every 54 inches and within 12 inches of a junction box. There are missing coverplates which should be installed.

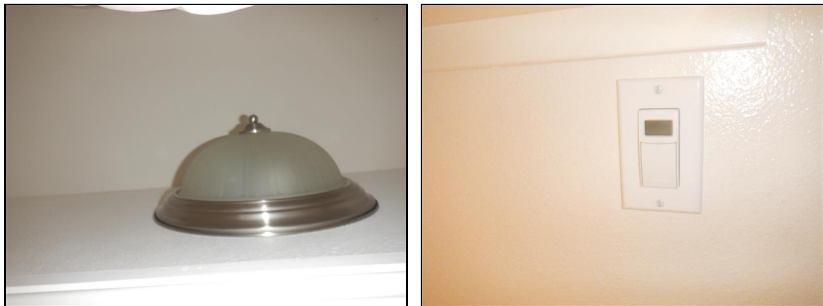
**REPAIR / REPLACE** A light in the downstairs hallway closet did not respond. The timer did not function and should be serviced.

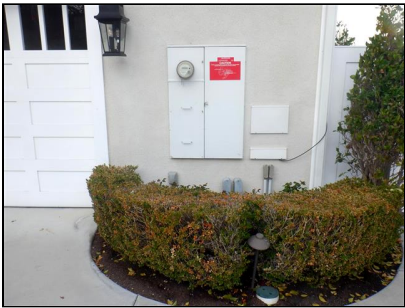
**REPAIR / REPLACE** (1) The main service panelboard does not have 36 in x 30 in of clear space which is mandated and clearance should be provided.

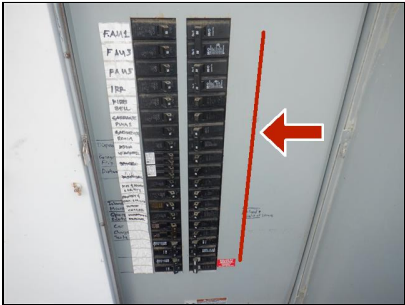
**REPAIR / REPLACE** (2) A number of circuits within the main service panelboard are not properly labeled. They should be so that the appropriate load calculations and breaker sizes could be determined.

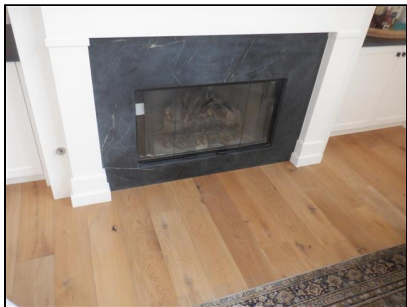
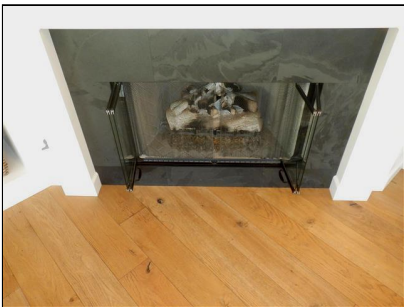
The fireplaces in the living room and family room do not have a distinguishable hearth extension, which should extend 16 in. in front of the openings and 8 in. beyond the sides of the openings.

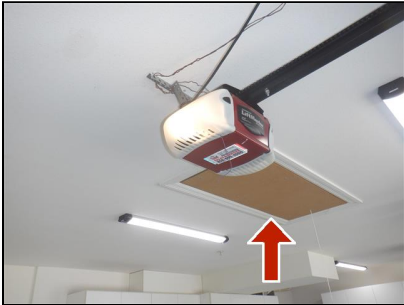
A pull-down ladder assembly in the garage ceiling violates the necessary fire separation between the garage and the dwelling. It should be replaced with a fire rated one, or the wall of the residence beyond it must be dry-walled with .5 in. drywall. A qualified Contractor is recommended.

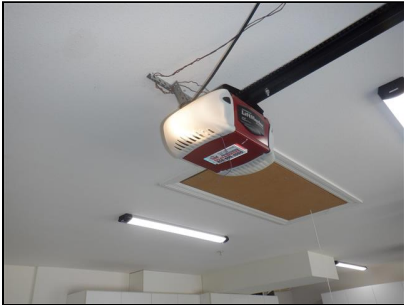
(1) Two garage door opener auto reverse pressure sensors did not respond to test, which pose potential safety hazards that should be serviced.

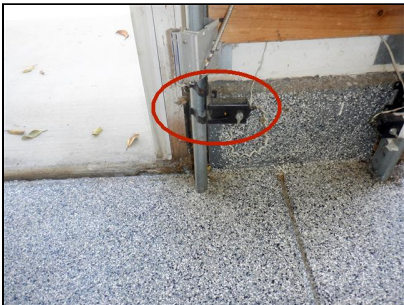
(2) The infrared auto-reversing sensor mechanisms (photo-electric eyes) of an opener are too high. The vertical distance between the photo-electric eye beams and the slab floor should be no more than 6 inches.

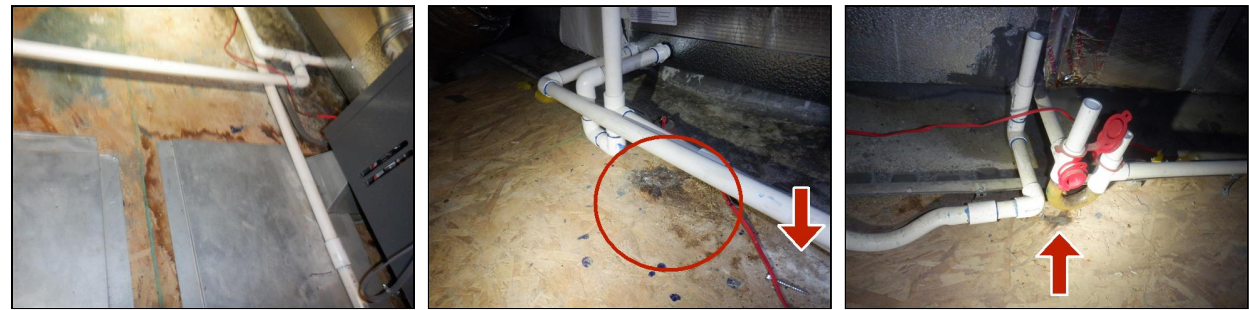
**REPAIR / REPLACE** There are stains on the platform under the condensate lines, the cause of which should be determined. A qualified HVAC Contractor is recommended.

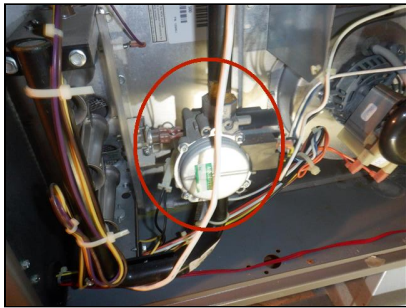
**SAFETY CONCERN** (1) There is a gas odor in the vicinity of the control valve of the furnace in the lower attic (primary bedroom closet) that poses a safety hazard and should be serviced as soon as possible. A qualified HVAC Contractor is recommended.

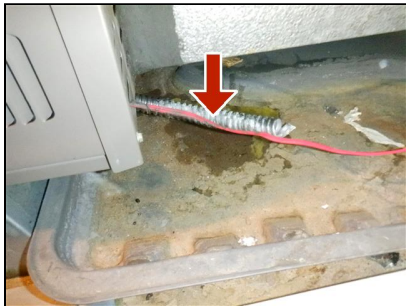
The evaporator coil appears to be leaking into the auxiliary drain pan as noted by moisture there. The coil may be cracked and may need replacing. A qualified HVAC Contractor is recommended.

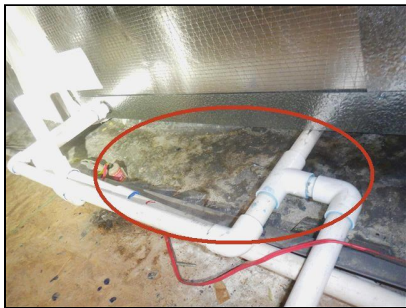
An auxiliary drain pan has water stains inside from condensate which should be serviced. The pan is beneath a newer HVAC system. A qualified HVAC Contractor is recommended.

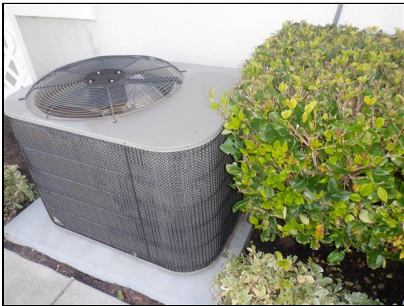
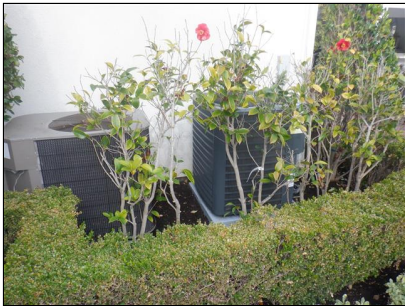
(1) There is foliage encroaching on the condenser(s) which should be maintained six inches away to allow proper air intake.

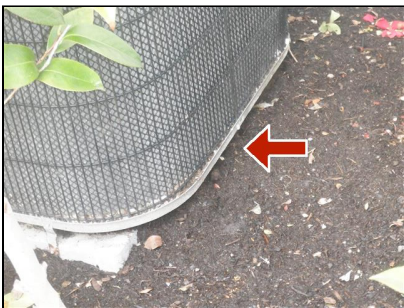
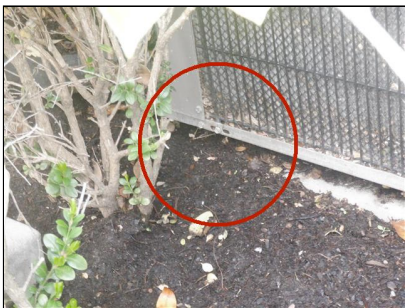
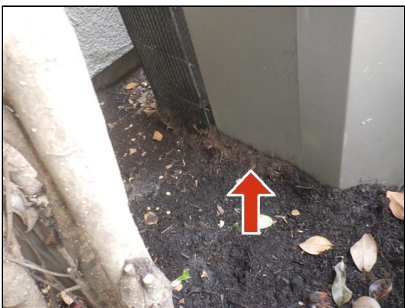
(2) A condensing coil is raised but not to the recommended 3 in. above the surrounding grade. The fins can draw debris into them. Dirty fins can effect the efficiency of the system.

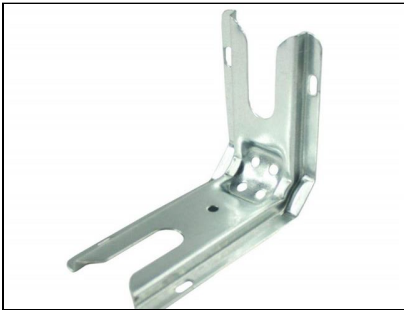
(1) The range in the guest house is not equipped with an anti-tip bracket which prevents the range from tipping, or its contents from spilling, should a child attempt to climb on its open door. This is a recommended safety feature that should be installed and particularly if children visit or occupy the residence.

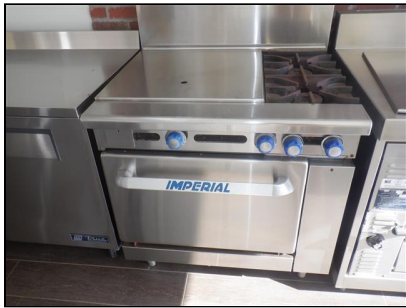
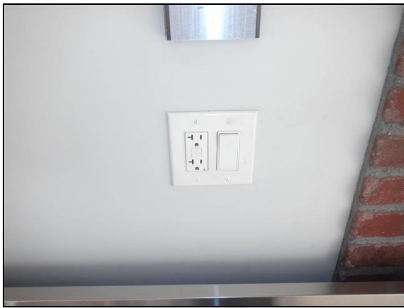
The ignition did not light the gas of the gas range griddle, oven and cooktop. This may be due to a tripped GFI outlet that cannot be reset, but the cause should be determined. The range should be serviced by a qualified Appliance technician before the end of the inspection contingency period.

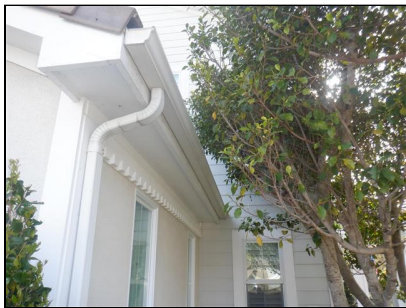
(1) GENERAL INFORMATION - There are tree limbs growing near the residence that should be regularly trimmed and monitored to insure that they do not impact or damage the roof or allow entry of rodents and insects.

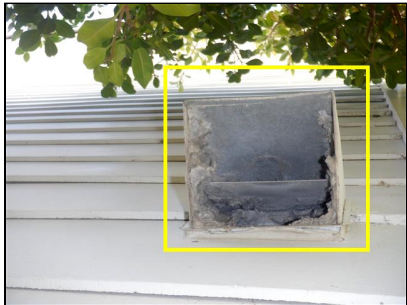
(1) The dryer duct is lined with lint, which poses a potential fire hazard and reduces the efficiency of the dryer. -Duct Cleaning Contractor is recommended

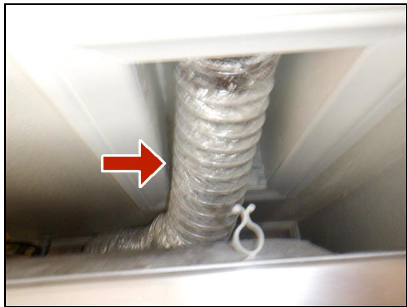
(2) The corrugated dryer duct is a type that traps lint, poses a potential fire hazard and should be replaced with a flexible metal type.

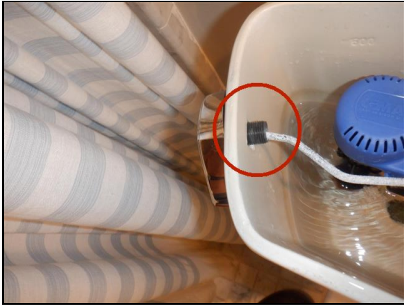
(1) The toilet flush valve handle is not secure in bathroom 6 and should be serviced.

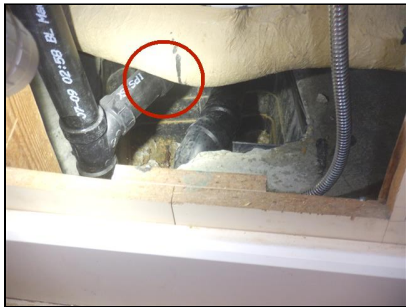
**PRIORITY REPAIR** (6) The hydro-spa tub drain leaks under the tub and should be serviced.

Water/Stains Under Tub

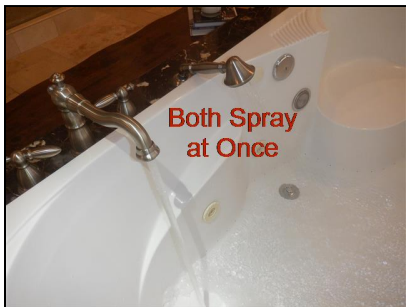
**REPAIR / REPLACE** (7) The hydro-spa tub diverter valve does not appear to function properly and should be serviced.

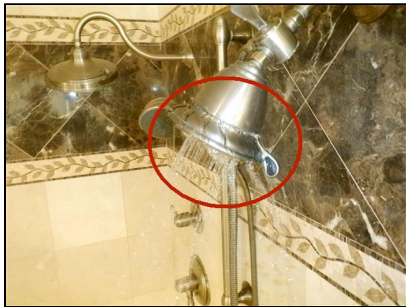
**REPAIR / REPLACE** (8) The showerhead in the primary bathroom shower leaks and should be serviced.

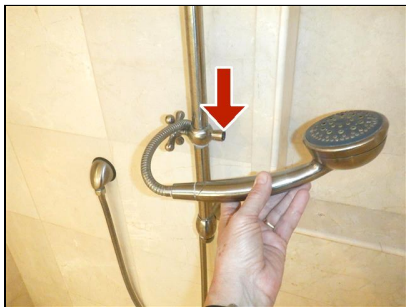
**REPAIR / REPLACE** (9) The shower hand sprayer mount in the primary bathroom shower is damaged and should be serviced.

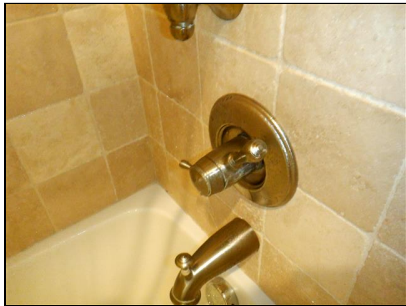
**REPAIR / REPLACE** (10) The upstairs bathrooms tub-shower mixer valves did not produce hot enough water and should be serviced.

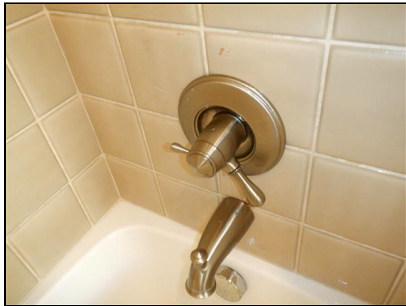
**REPAIR / REPLACE** (11) The fixtures in the tub-shower in bathroom 3 & 4 are not caulked and should be serviced to prevent the potential for moisture intrusion and damage.

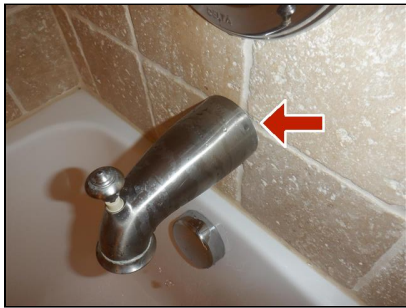
**REPAIR / REPLACE** (13) One of the fixtures in the tub-shower in bathroom 5 is not caulked and should be serviced to prevent the potential for moisture intrusion and damage.

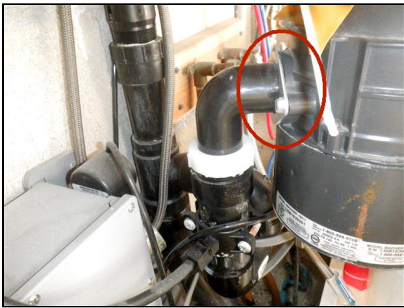
**REPAIR / REPLACE** There is a leak beneath the exterior sink, which should be serviced.

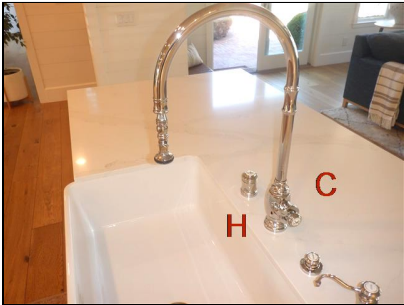
(1) The kitchen sink faucet is hot and cold reversed and should be serviced.

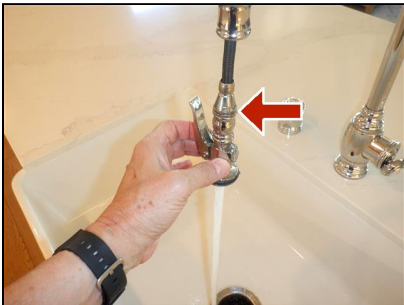
(2) The hand sprayer on the kitchen faucet leaks and should be serviced.

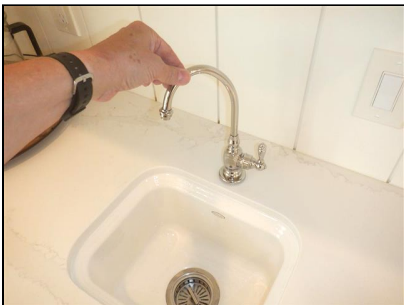
(3) The bar sink faucet is loose and should be secured.

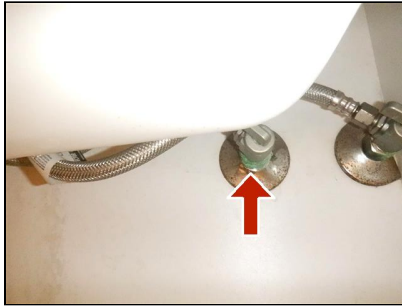
There is a corroded angle stop beneath the laundry sink, which should be replaced to prevent a leak.

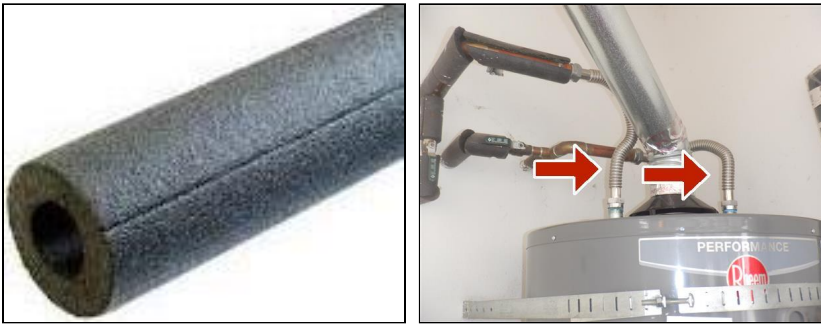
The inlet and outlet lines on the water heater are not insulated and insulation should be added for energy efficiency.

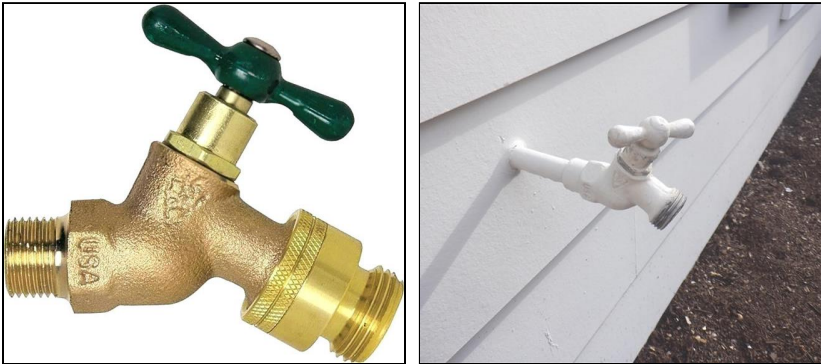
**REPAIR / REPLACE** Three or more hose bibs do not include backflow devices, which are required by building standards to prevent back-siphoning of grey water into the potable water supply.

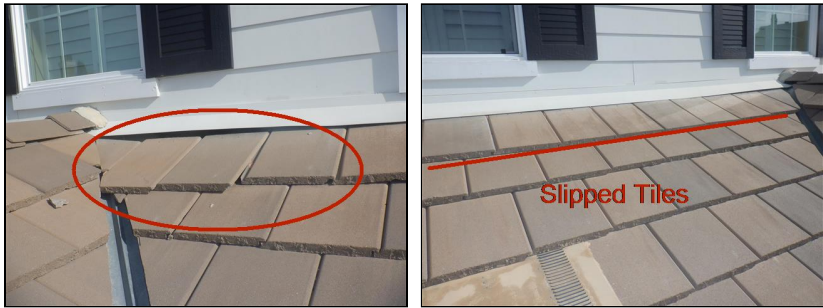
- (1) There are 12 or more slipped or displaced tiles at the front roof to wall junction, which should be serviced or the roof may leak. Evaluation and repair of the entire roof by a licensed Roofing Contractor is recommended before the end of the inspection contingency period.

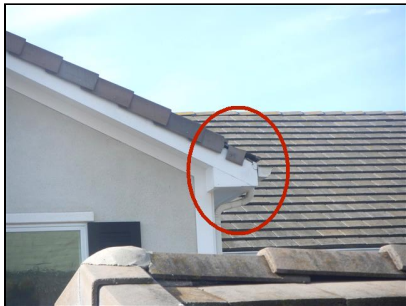
(2) There are 2 broken rake tiles at the back of the home, which should be serviced or the roof may leak. Evaluation and repair of the entire roof by a licensed Roofing Contractor is recommended before the end of the inspection contingency period.

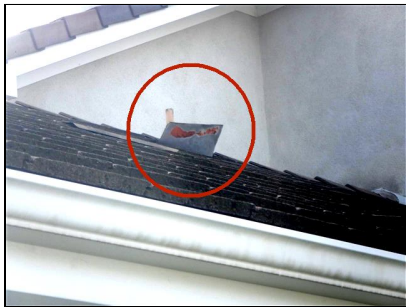
The toe of the flashing at a roof jack has been lifted and should be serviced to prevent a leak.

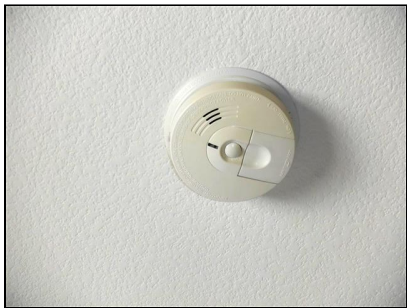
The hardwired smoke alarm in the loft hallway is beyond its design life of 10 years and should be replaced. Old alarms have a higher failure rate and should be replaced for safety. Depressing the test button does not confirm the smoke sensor will function in the event of a fire. New construction standards require a 10-year battery type.
