## HOME INSPECTION REPORT

**JOE BUYER**

1234 ALLRIGHT AVE, CARLSBAD, CA 92009

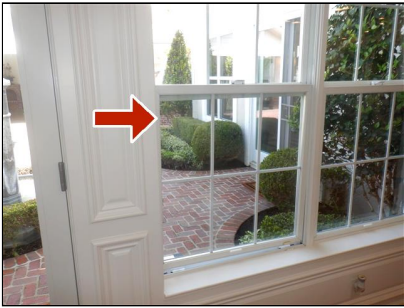
Dining Room

(2) Six or more windows have damaged balancers and should be serviced for the windows to open and close properly or to stay open.

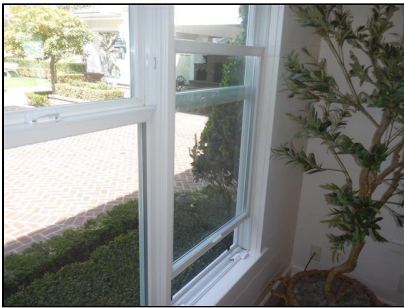
Bedroom 2

(3) Five or more windows are difficult to shut and need service to balancers.

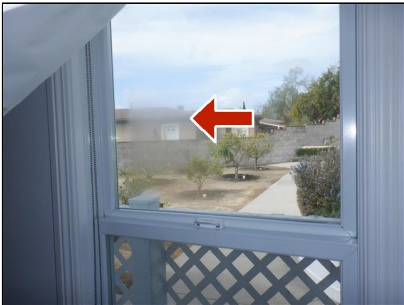
Primary Bathroom

**REPAIR / REPLACE** (4) There are 11 or more windows with broken hermetic seals, (fogged windows), which should be replaced. Condensation or fogging may continue to form between the panes of glass over time making them more unsightly.

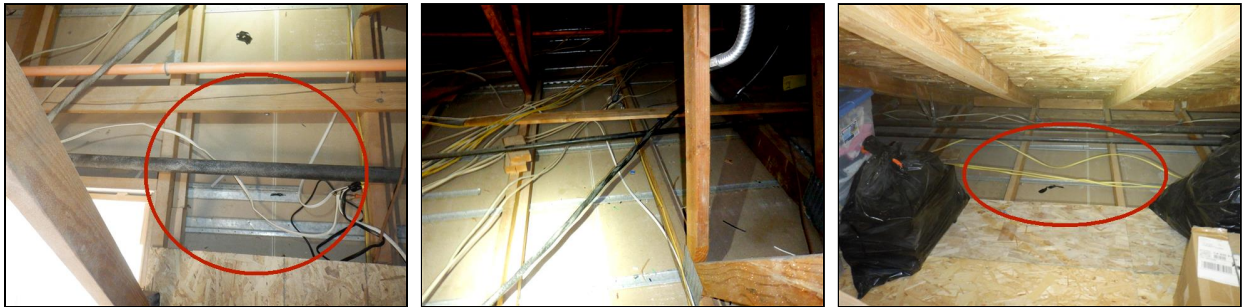
**SAFETY CONCERN** (2) There is electrical NM cable within the garage attic, which is not properly secured. It should be fastened to the framing every 54 in. and within 12 in. of a junction box or termination.

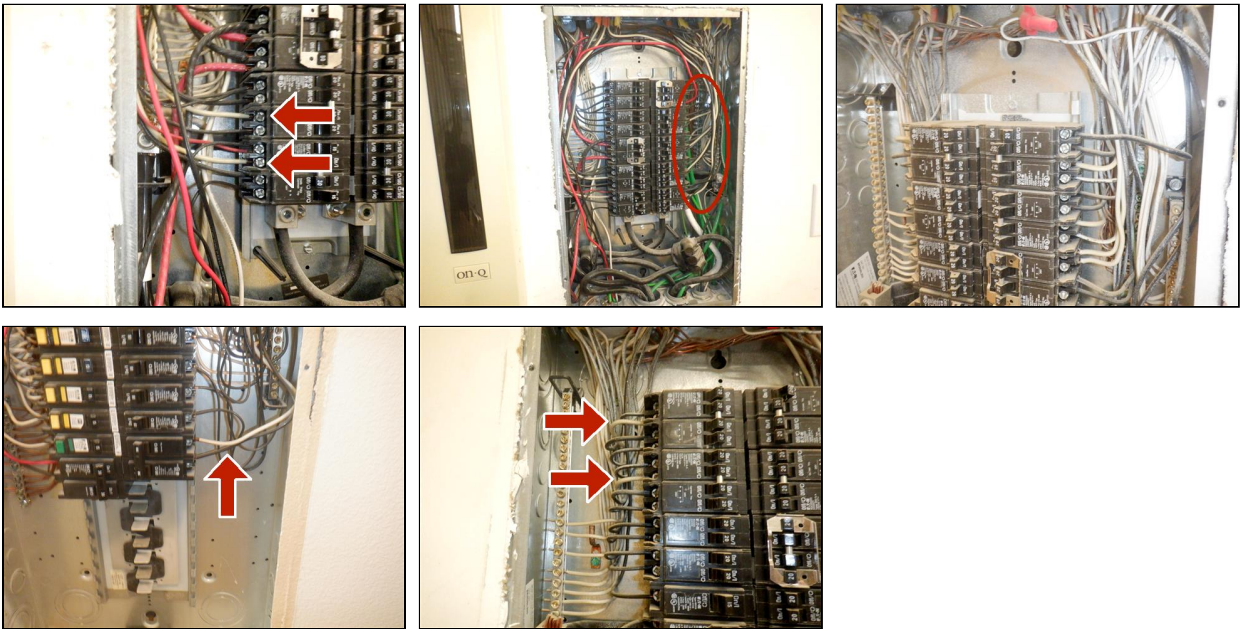
There are neutrals (grounded conductors) that are being used as hots (ungrounded conductors) in the sub panels that should be re identified with black tape.

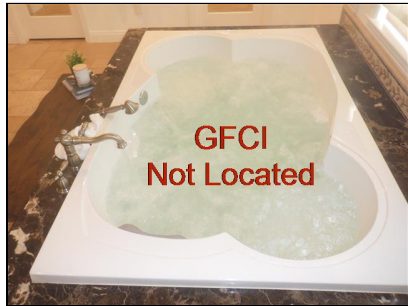
The hydro-spa tub in the primary bathroom could not be confirmed to be GFCI protected and should be confirmed to be by a qualified Electrician.

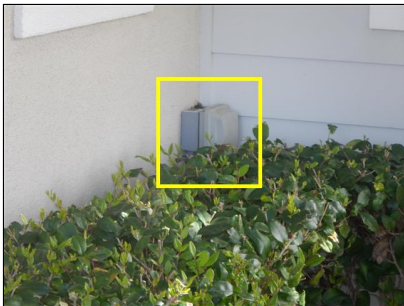
Power is Off

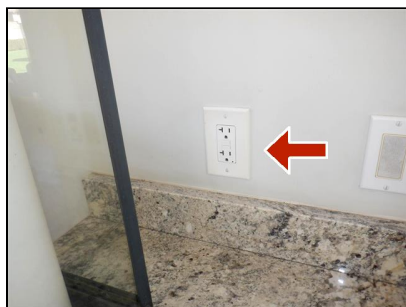
(3) A GFCI outlet right of the exterior fireplace is redundant to the one at the left side of the fireplace and should be a standard outlet.

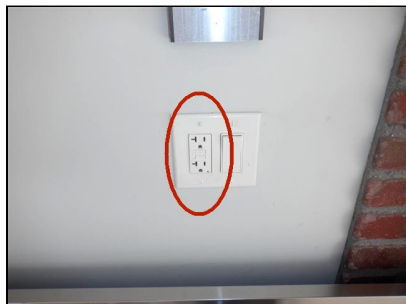
(4) A GFCI outlet at the exterior kitchen is tripped, cannot be reset and should be serviced.

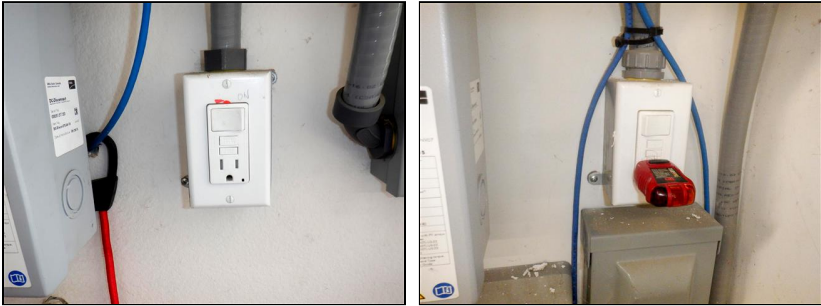
**SAFETY CONCERN** (3) Two garage receptacle outlets have no power and should be serviced. (at solar system)

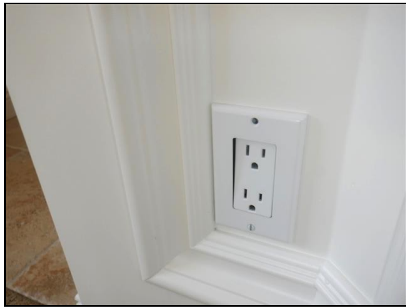
**SAFETY CONCERN** A receptacle outlet in bedroom 3 is not properly secured and should be serviced.

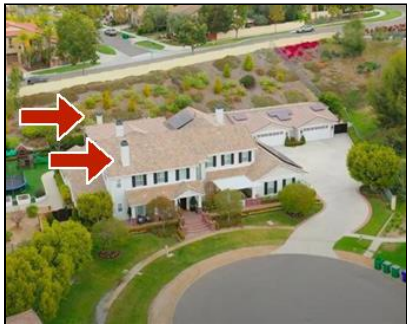
(2) There are more chimneys than fireplaces. Inquire with the seller for more information.

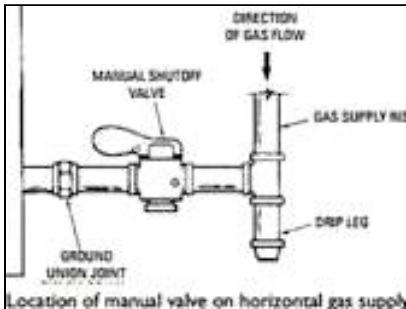
(2) UPGRADE -There are no sediment traps installed on two HVAC systems, which are required by newer building standards and should be installed.

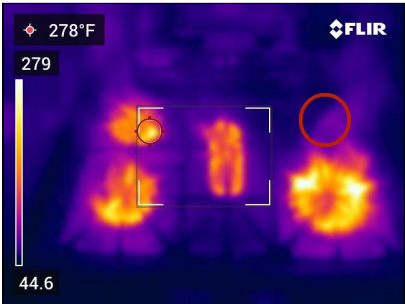
One of the cook top burner in the guest house did not respond and should be serviced. -

Appliance technician is recommended

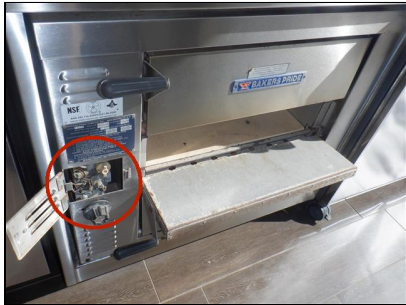
The pizza oven pilot was not lit and should be serviced.

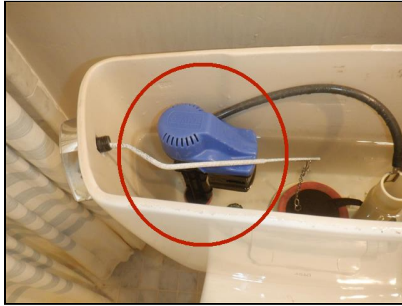
(2) The ball cock in bathroom 6 cycles on and off when refilling the tank and should be replaced.

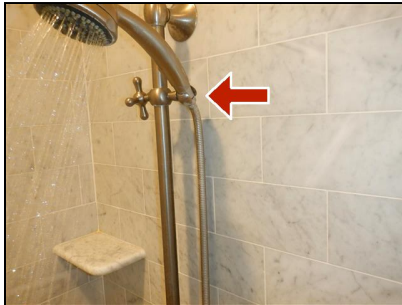
(3) The showerhead hose in bathroom 6 leaks at the connection and should be serviced.

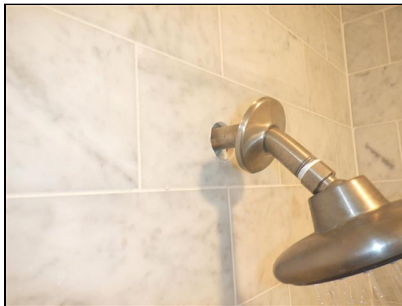
(4) The escutcheons in the bathroom 5 & 6 shower are not caulked and should be serviced to prevent moisture intrusion and damage.

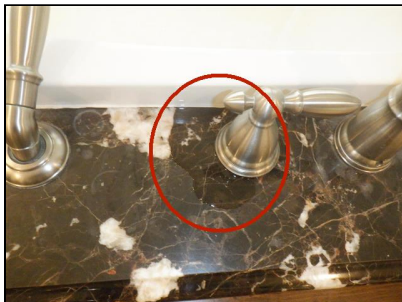
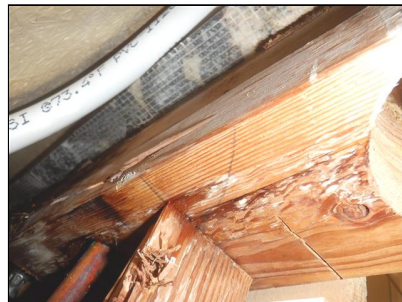
(5) A hydro-spa tub valve leaks at the stem. Water drips under the tub and it should be serviced.

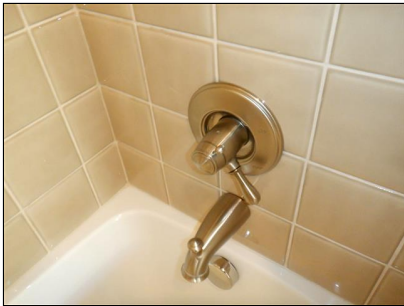
Bathroom 3

**REPAIR / REPLACE** (10) The upstairs bathrooms tub-shower mixer valves did not produce hot enough water and should be serviced.

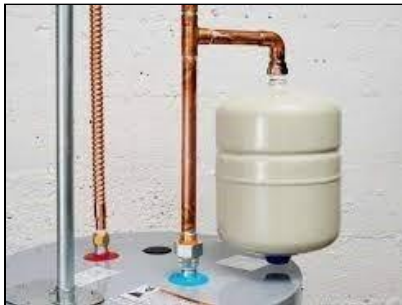
UPGRADE – There is no expansion tank installed on the inlet line. This is required by building standards to prevent thermal expansion from causing high water pressure that can contribute to plumbing leaks.

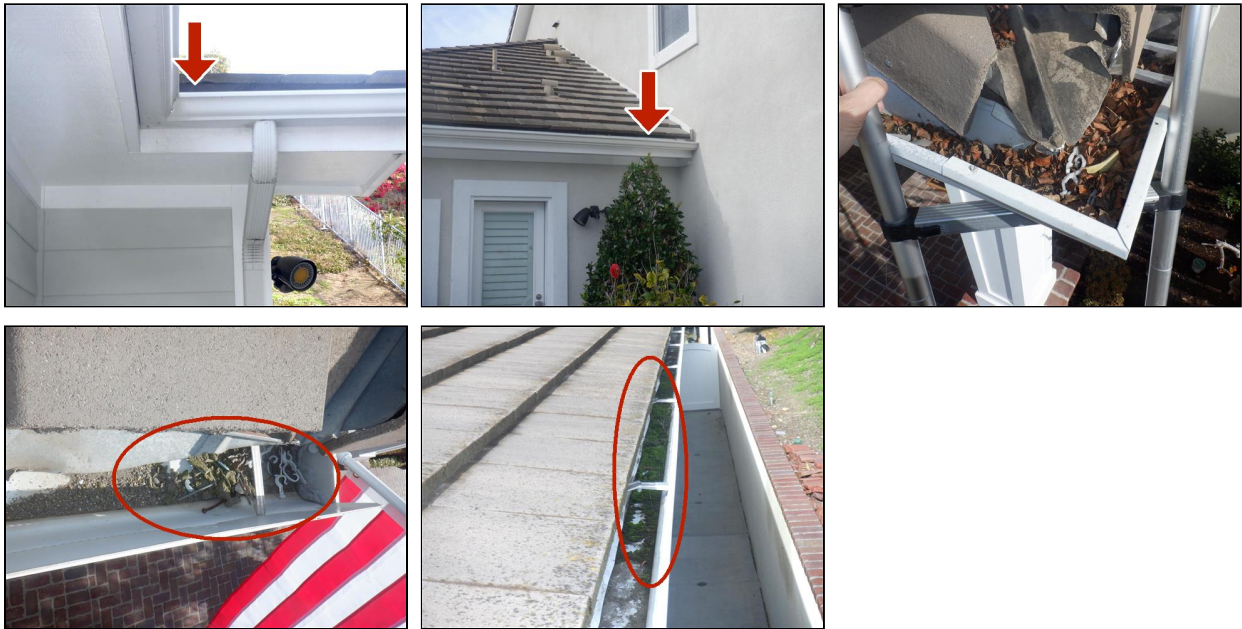
The gutters need to be cleaned and serviced to function properly. The attached garage gutters are not pitched to drain. The gutters on the added garage and front of the home should be cleaned, etc.

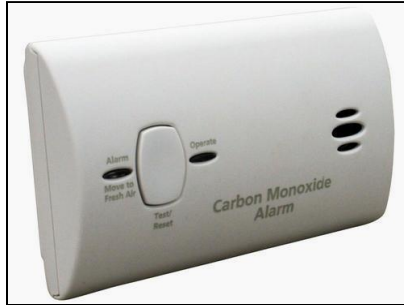
There are no carbon monoxide alarms installed outside each sleeping area, in close proximity to bedrooms on each floor. They are required by California law and should be installed before the end of the inspection contingency period.
